**SECOND FIVE-YEAR REVIEW REPORT
ROCKAWAY TOWNSHIP WELLS SUPERFUND SITE
ROCKAWAY TOWNSHIP, MORRIS COUNTY, NEW JERSEY**

September 2015

**U.S. Environmental Protection Agency
Region 2
New York, New York**

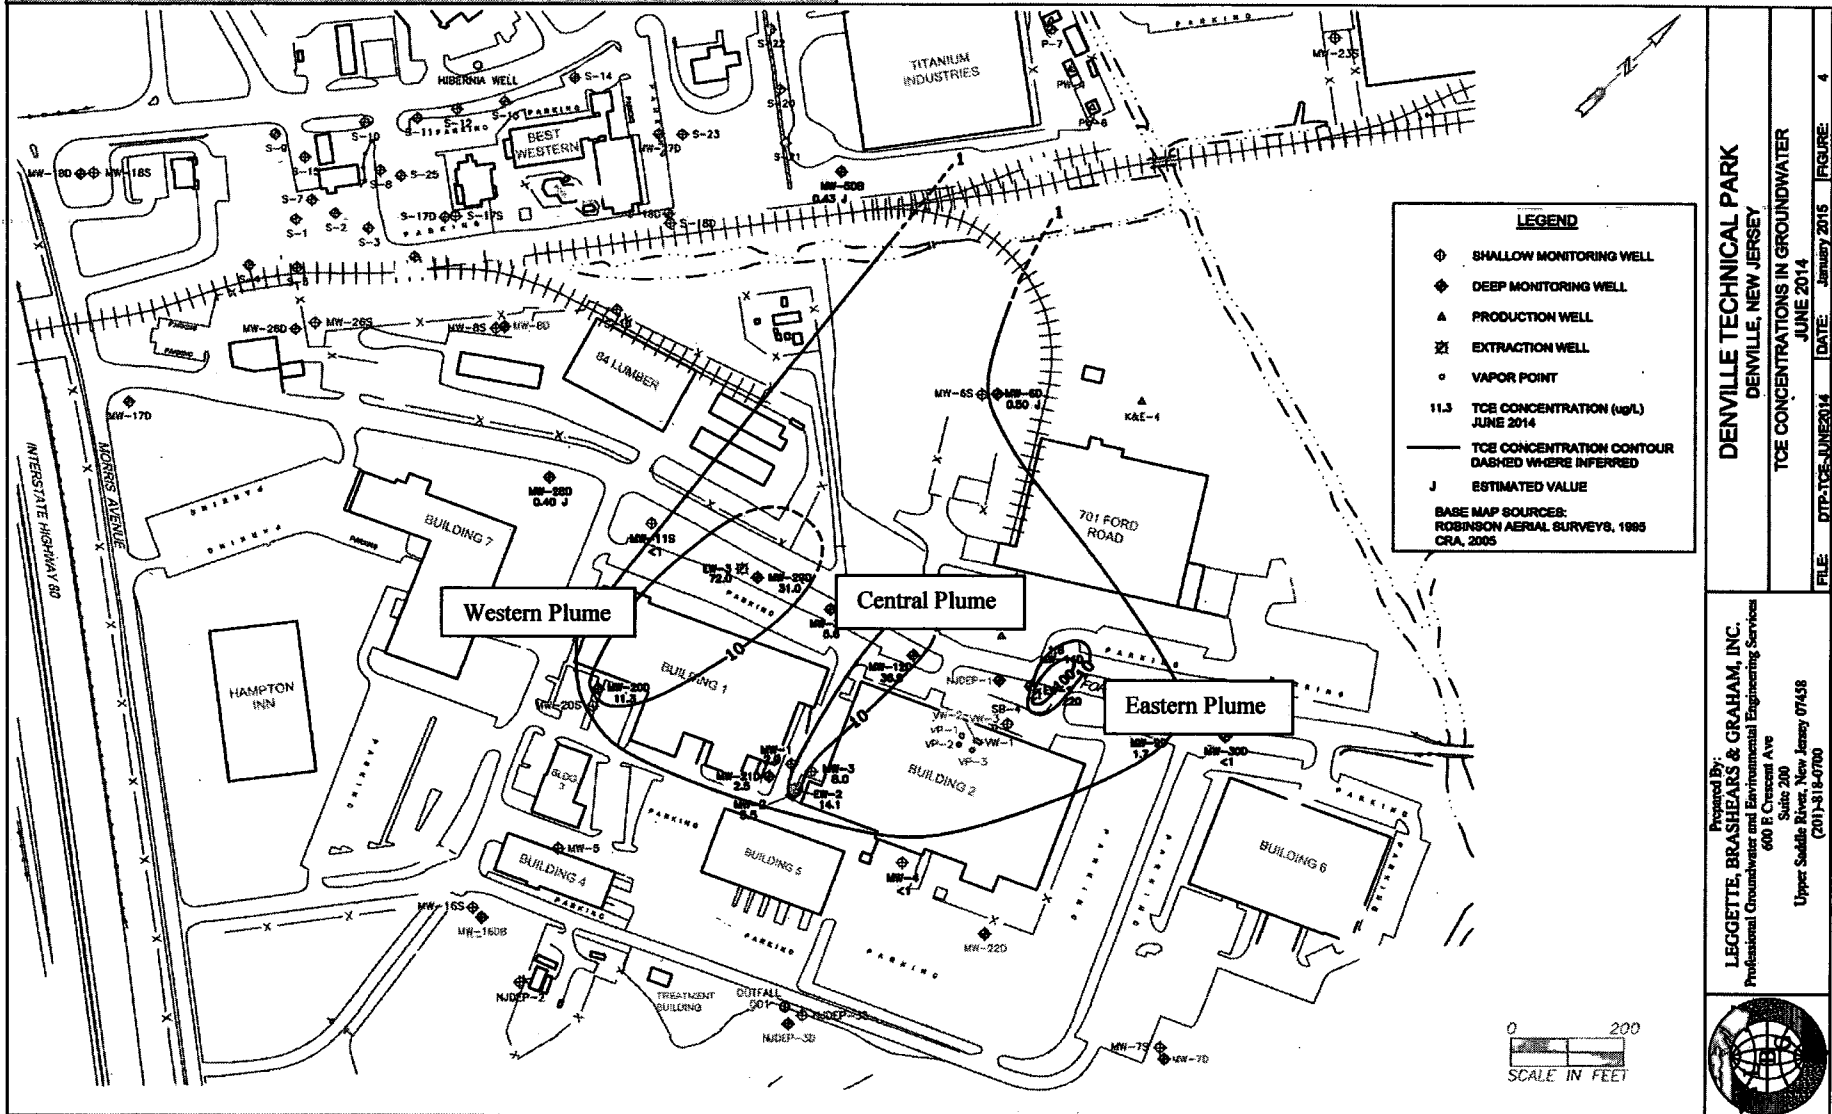
Figure 3: TCE Concentrations in Groundwater

In summary, three distinct groundwater plumes originate from three different source areas. The primary COCs in the eastern plume are PCE and TCE. The primary COCs of the central plume are 1,1,1-TCA and TCE. The primary COCs of the western plume are TCE and 1,1-DCE. Extraction wells EW-1, EW-2, and EW-3 are dedicated to reducing contaminant mass in each respective plume. Data from this review period indicate that the majority of the mass is present in the eastern and central plumes while EW-1 has shown the highest contaminant concentrations, specifically TCE, observed in the extraction wells. MW-3 meanwhile has shown the highest contaminant concentration during this review period, with TCE at 8,080 ug/L in 2011. The groundwater contaminant plumes appear to be contained by EW-2 and EW-3. There is some question regarding EW-1, as its effectiveness appears to have become reduced with time and although there is monitoring along the lateral limits of the plume (i.e. MW-9D, MW-12), there is currently no downgradient monitoring of the plume. Therefore, the downgradient extent of the eastern plume is currently not delineated.

In regard to contaminant plume extent and monitoring, while annual reports submitted for the project indicate declining to stable levels of site-related contaminants of concern, the monitoring point areal coverage in some areas was noted as deficient in past comments. To this end, a well cluster was recommended to fill in the gap in the area of the 701 Ford Road property. A review of monitoring data from the last five years affirms that there are insufficient monitoring wells downgradient to confirm the extent of the groundwater plume. That recommendation is reiterated in this FYR.

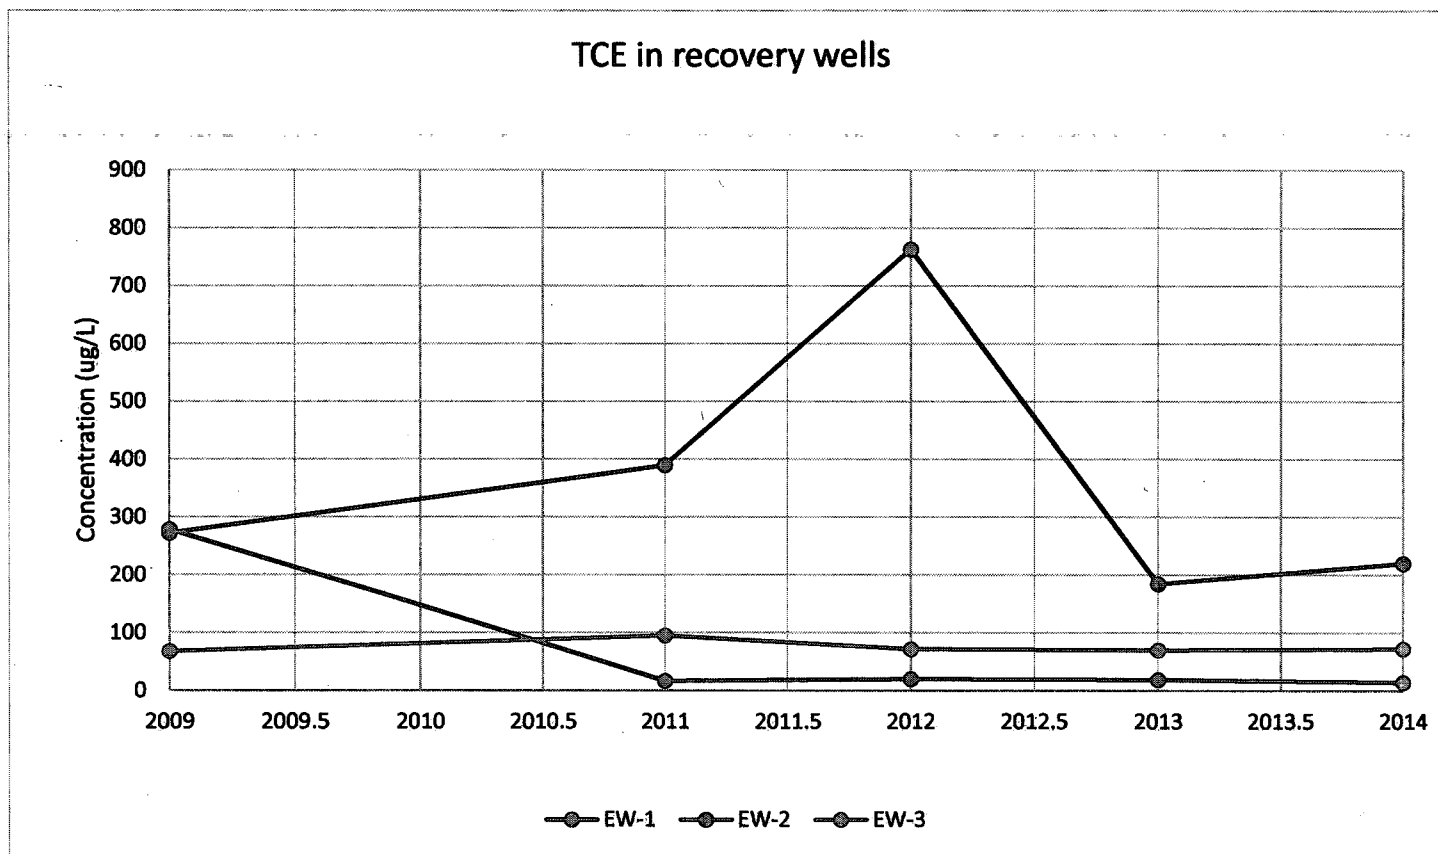
Figure 7: TCE concentrations over the five-year review period in recovery wells

It should be noted that overall extraction rates of EW-1 have reduced with time and there is some indication that EW-1 has become less effective with time. Little apparent drawdown was evident in monitoring wells situated in close proximity to EW-1, even in MW-14, which is located about ten feet away. However, while EW-1 has been extracting less than 10% of the volume extracted by EW-3, a comparison of the mass of VOCs extracted at all three wells indicates that EW-1 (3.8 pounds per million gallons of water) is currently extracting the greatest percentage VOC mass. Thus, this would indicate that EW-1 continues to draw contaminant mass in its immediate vicinity, but its capture zone is limited. Another line of evidence suggesting that its effectiveness has diminished with time are the previously observed increasing concentrations evident in MW-9D, MW-12D, and MW-14D although VOC concentrations appear to be relatively constant during this review period.

Affect Current Protectiveness	Affect Future Protectiveness	Party Responsible	Oversight Party	Milestone Date
No	Yes	PRP	State	3/31/2016
OU(s): <i>Operable Unit 1 - Groundwater</i>	Issue Category: Operations and Maintenance			
	Issue: Performance of Extraction Well No. 1			
	Recommendation: Extraction Well No. 1 should be rehabilitated so that it can perform at its operation flow rate of five gallons per minute.			
Affect Current Protectiveness	Affect Future Protectiveness	Party Responsible	Oversight Party	Milestone Date
No	Yes	PRP	State	3/31/2016
OU(s): <i>Operable Unit 1 Groundwater</i>	Issue Category: Operations and Maintenance			
	Issue: Indoor Air Monitoring/Downgradient area indoor air monitoring			
	Recommendation: Sub-slab depressurization system operations and performance for Buildings 1 and 2 have been documented through the presentation of vacuum pressure readings. Indoor air samples should be collected and analyzed for Buildings 1 and 2 to confirm system performance. Additional efforts to identify indoor sources should also occur. Indoor air data at structures overlying the downgradient plume area have not been collected/analyzed. Indoor air samples should be collected at 701 Ford Road and Buildings 3, 5 and 6 area buildings.

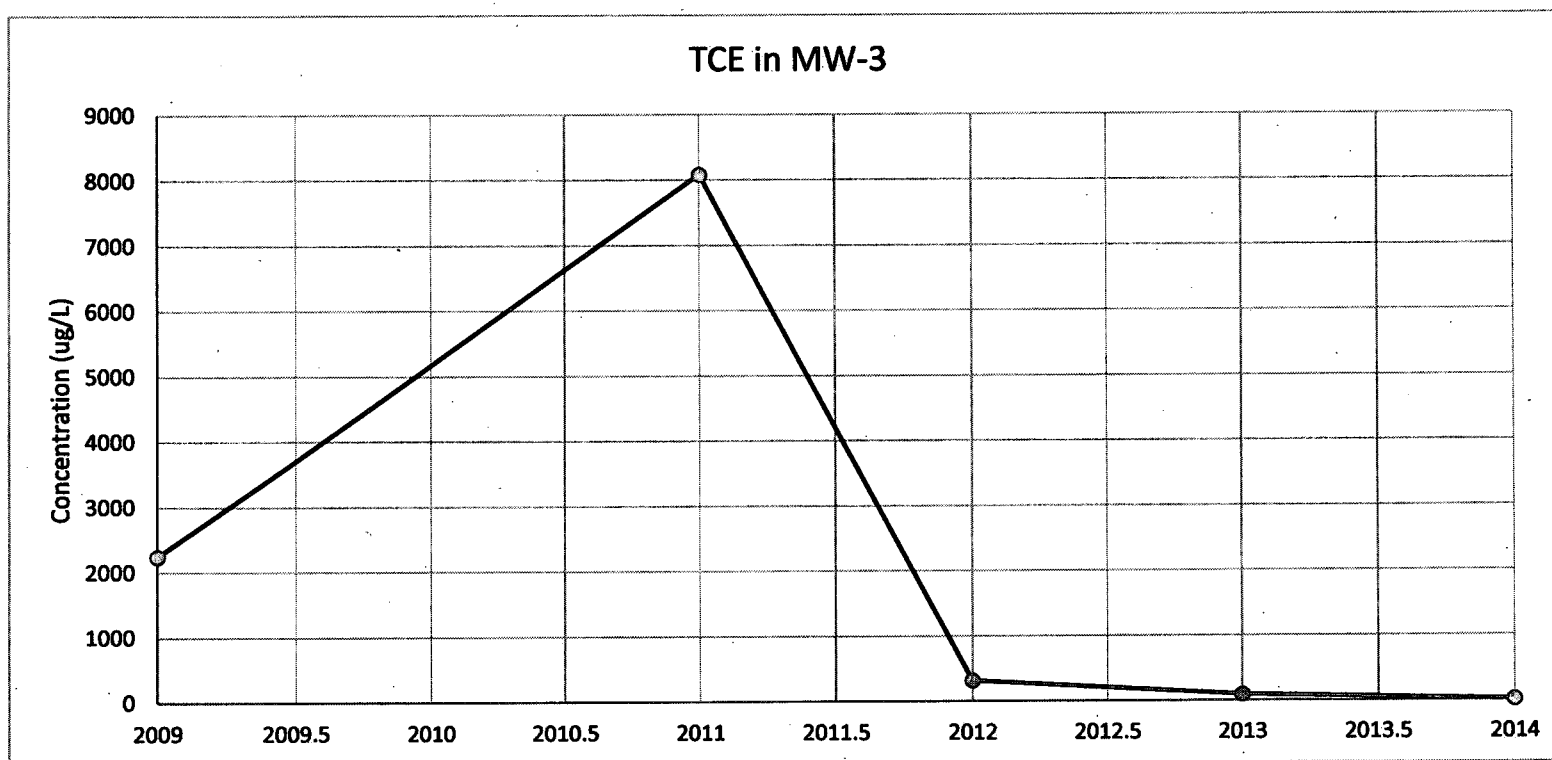
Figure 8: TCE concentrations in MW-3

The well showing the maximum TCE concentration (8,080 ug/L) during this five-year review period.

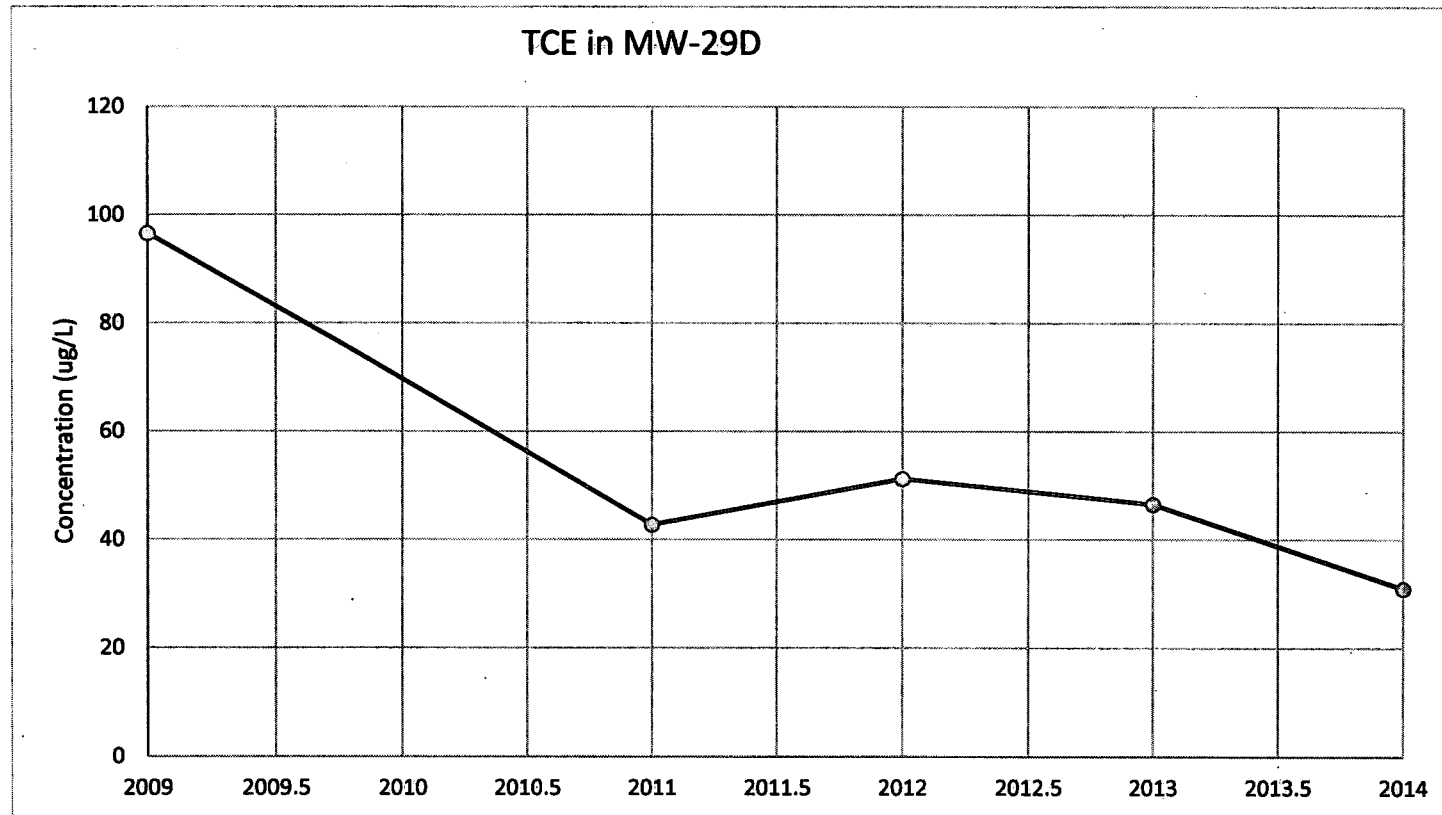
Figure 9: TCE concentrations in MW-29D

TCE contamination of groundwater is found in three distinct plumes. The western plume has no identified source and shows comparatively lower concentrations of COCs compared to the central and eastern plumes. Groundwater extraction well EW-3 was designed to intercept the western plume. The remedy addressing the western plume is functioning as intended. Extraction well EW-3 is creating a significant cone of depression in the water table which acts as a hydraulic boundary to the contamination. Additionally, all the monitoring wells located in the western plume (i.e., MW-11S, MW-29D, MW-32D) have all shown declining TCE concentration trends since 2005.

Show overall decreasing concentrations during this five-year review period.
